OPTIMISATION OF WINTER MAINTENANCE ON PEDESTRIAN AND CYCLING PATHS - CASE STUDY RR 110

J. Klang

Centres for Economic Development, Transport and the Environment,
Traffic System Department, Finland

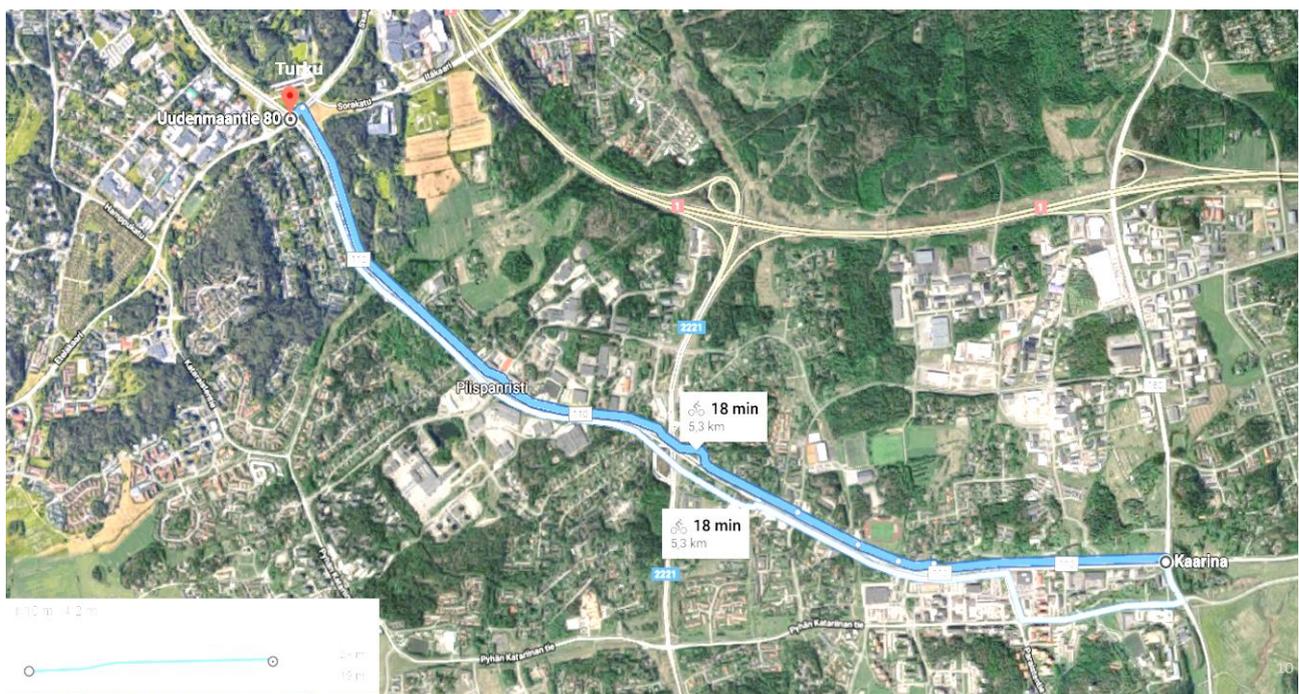
Figure 4 - The target research area of Rural road 110 is highlighted in blue. Map [6].

A case study was carried out on the pedestrian and cycle paths of Road 110 between Turku and Kaarina. On a 5 km stretch of road, the combined pedestrian and cycling paths are separated from the highways.

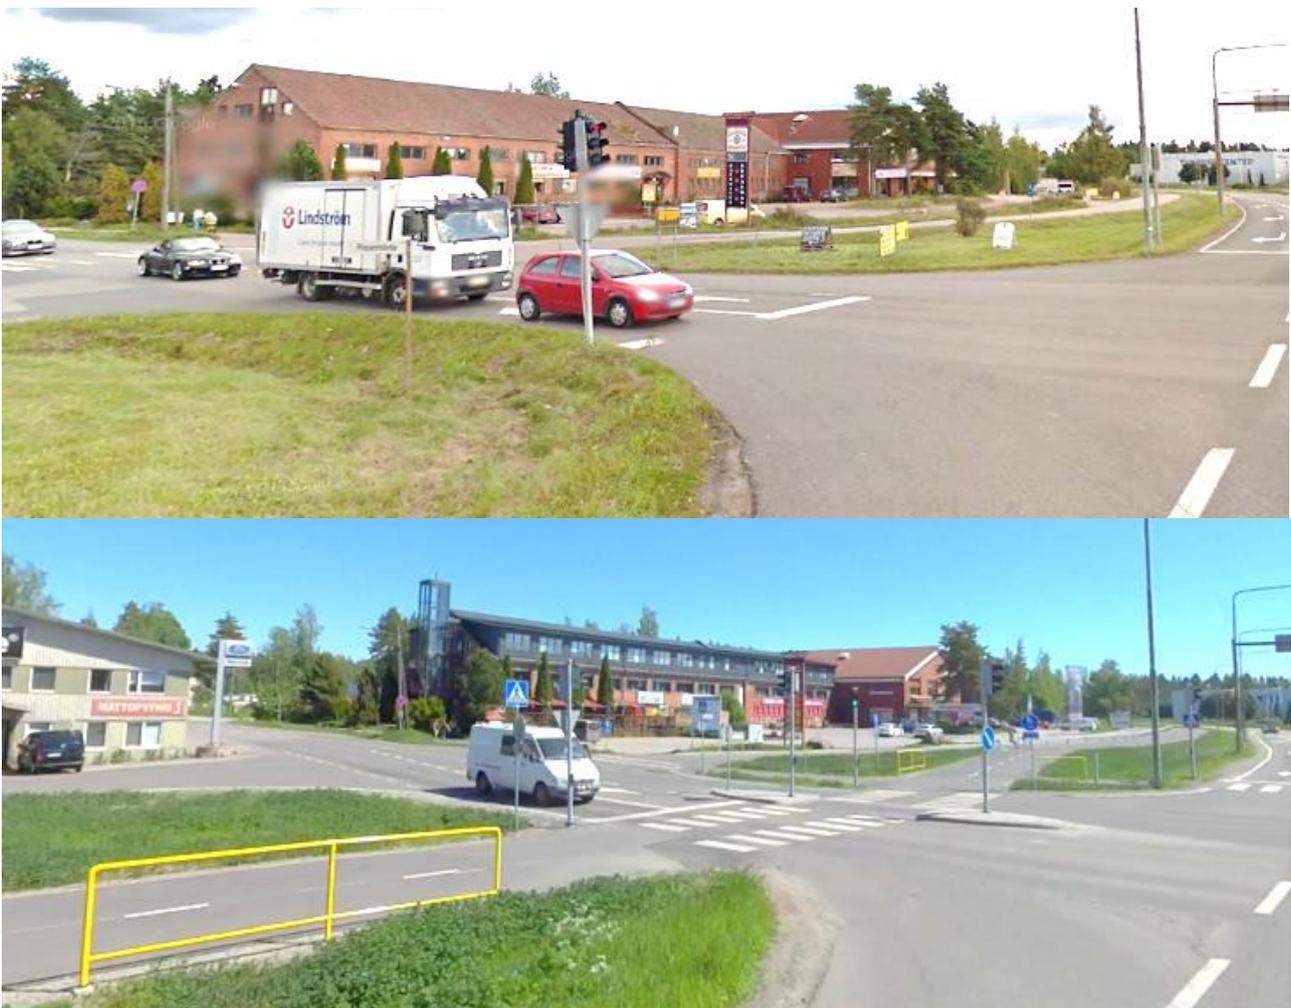
Figure 7 - Before 2018 and after 2021. Walking and cycling paths have now rebuilt in line with the pace 1. recommendations. Photo [7].

- it was completely resurfaced and the northern path was widened from three to five metres
- incomplete or inadequate sections of the route were improved and extended to improve route continuity
- directions on the northern path were shown by means of road markings
- handrails for cyclists were introduced on the route
- underpasses and interchanges were made safer and easier to maintain
- more space was made available for the snow cleared off the path by snowploughs
- signposts for cyclists were introduced on the section.

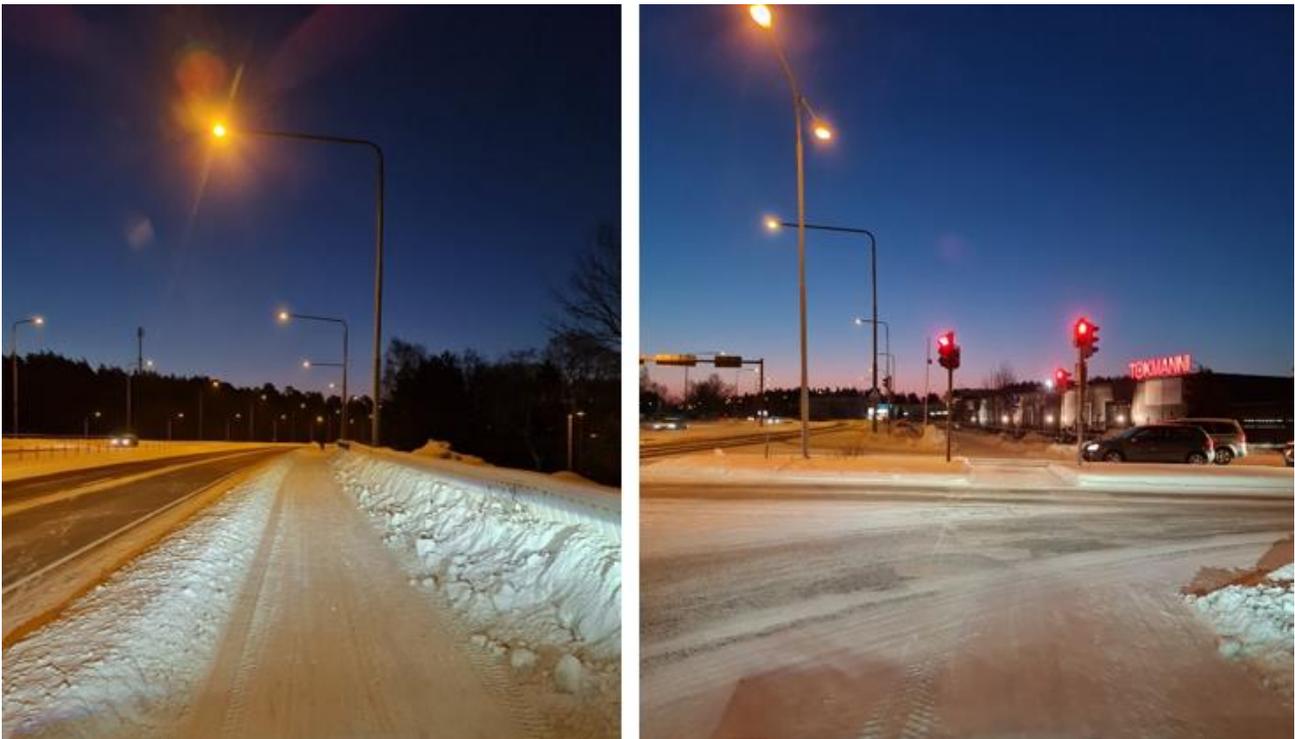
Figure 8 - The measures and quality level of winter maintenance renewed in line with the page 1. recommendations.
